Vasa 4/12/2022

#08846 (APE)

Bottom Unit with heel lifts and outsole, extensive sole repairs.

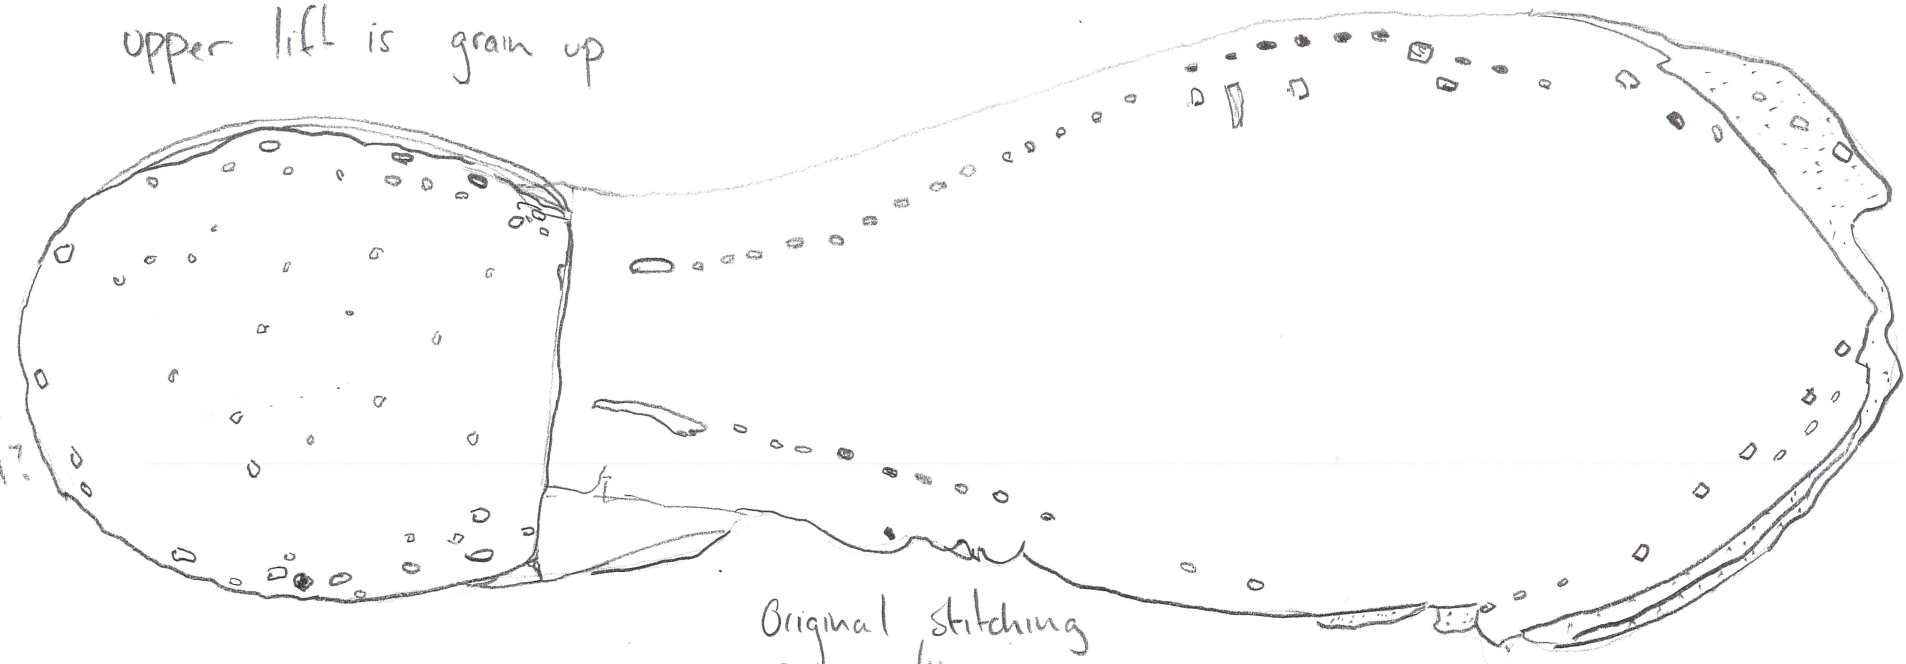
Top View

upper lift is grain up

Tiny holes in center of lift from pegging awl?

Original stitching @ 4.5"

- Outer Edge of heel worn and heel stack mashed over. Clear sign of supination

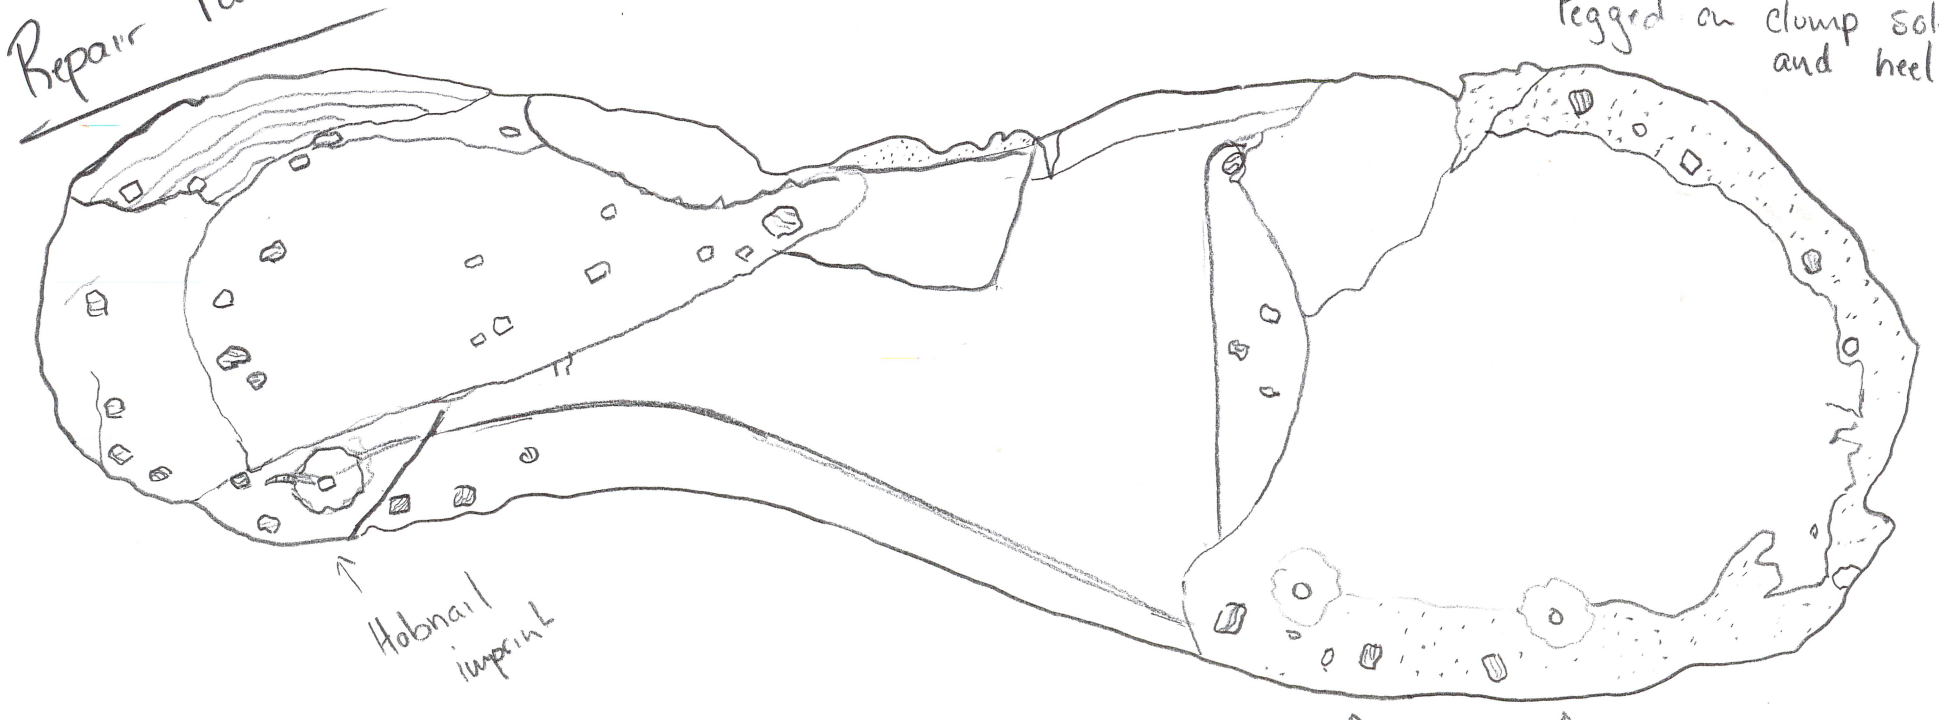
Bottom View

Repair Patch

Pegged on clump soles and heel lifts

Hobnail imprint

Hobnail staining on sole?
