Vasa 4/12/2022

#08846 (APE)

Bottom Unit with heel lifts and outsole, extensive sole repairs.

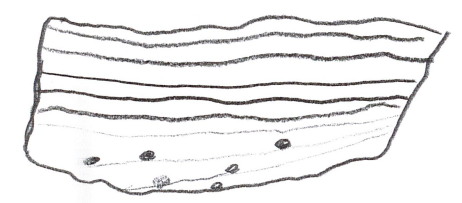
Top View

upper lift is grain up

Tiny holes in center of lift from pegging awl?

Original stitching @ 4.5"

- Outer Edge of heel worn and heel stack mashed over. Clear sign of supination

REPAIRS:

Pegged on clump soles and heel lifts
